# **Upper Rapid Creek Subwatersheds Riparian Project Stream Assessment Report**

**Developed for the  
Portneuf Soil and Water Conservation District**

**Prepared by  
Justin W. Krajewski  
Water Quality Resource Conservationist  
Idaho Soil Conservation Commission  
Pocatello, Idaho**

**March 2002**

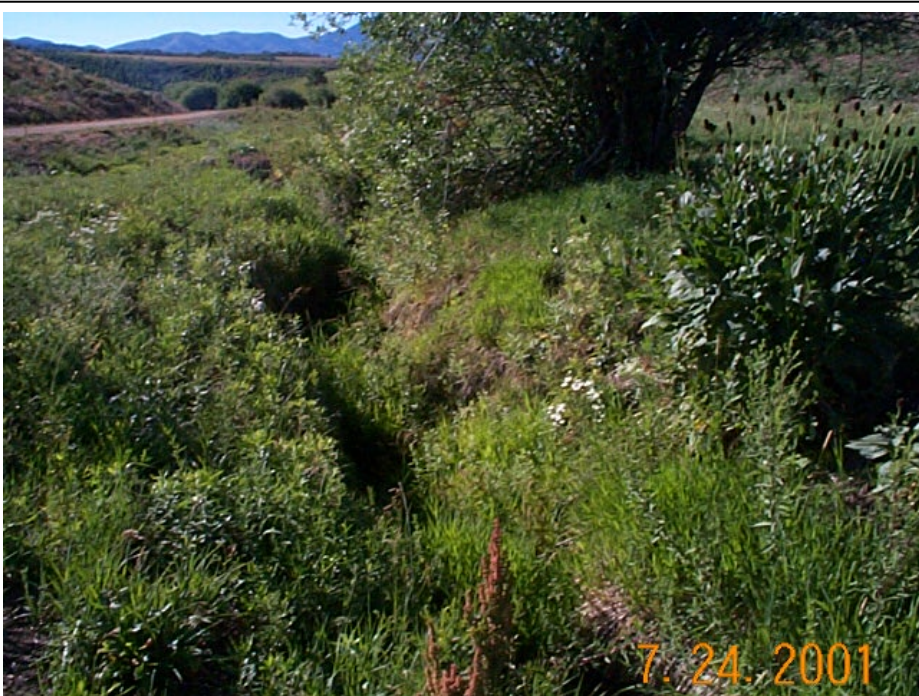
The channel was incised. Riparian zone vegetation extended at least one-third of the active channel width. Stream banks were moderately unstable. Grasses dominated the vegetative community with some willow species present. About 20% to 50% of the creek was shaded. Evidence of livestock access to the riparian area was noted. The reach was vertically unstable caused by numerous small headcuts and one wooden drop structure that was also a fish migration barrier and a small breached earthen dam or road crossing at the bottom of the reach. The reach was found to have erosion and cracking present on stream banks. Stream banks were 40% to 70% bare and covered with annual vegetation. Average bank height was about 3 feet high. Channel substrates were silts and gravels with numerous headcuts and evidence of recent deposition.

This photo of NFRC3b was taken looking downstream. The channel is incised with impacts livestock and the road.

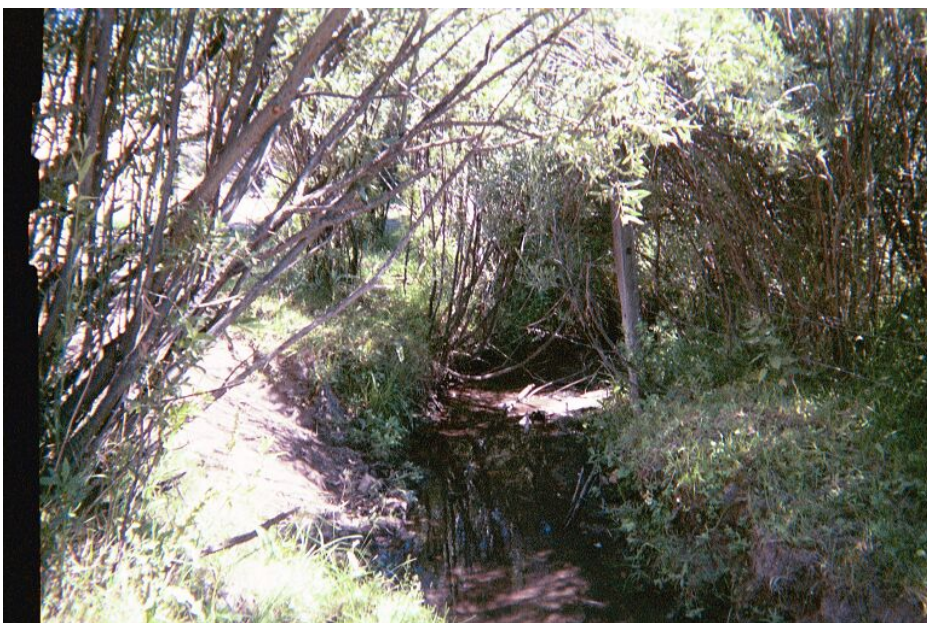
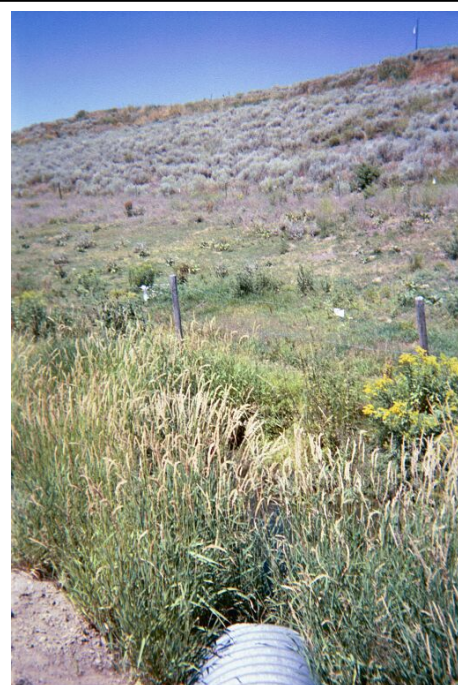
Stream banks were stable. No fish migration barriers were present within reach but occur in the reaches upstream from this one. About 50% of the creek was shaded. Occasional manure in the creek was noted. The reach was found to have erosion and cracking present on stream banks. Very little unprotected bank was present. Banks were covered with perennial vegetation. Average bank height was about 3 feet. Channel bottom in sand and small gravels with mobile material from recent deposition. NFRC5 flows into a road culvert and crosses under the county road. The creek is channelized and is located in the road ditch for about 600 feet until NFRC6 begins at an access road and culvert.

This photo of NFRC5 was taken looking downstream.

This photo of NFRC5 was taken looking downstream from the road.

- 1) Prescribed Grazing (NRCS PS-528A)
  - With Spring Development (NRCS PS-574), Water Well (NRCS PS-642), Fencing (NRCS PS-382), Watering Facility (NRCS PS-614), Pipeline (NRCS PS-516), Use Exclusion (NRCS PS-472), Channel Vegetation (NRCS PS-322), Tree/Shrub Establishment (NRCS PS-612)

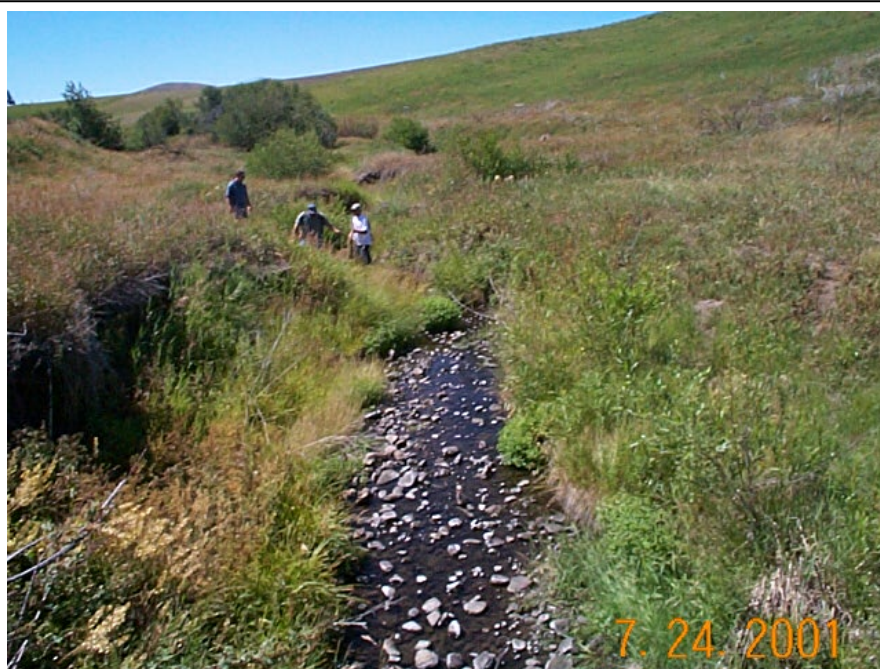
This photo of NFRC8 was taken looking downstream.

The channel was not incised. Riparian zone vegetation extended at least one active channel width. Stream banks were moderately stable. About 20% to 50% of the creek was shaded. No evidence of livestock access to the riparian area was noted.

There were no fish migration barriers in this reach. The reach was found to have erosion evident. Stream banks covered with perennial vegetation. Channel banks about 3 feet high. Channel bottom in gravels and cobbles with very little evidence of recent deposition.

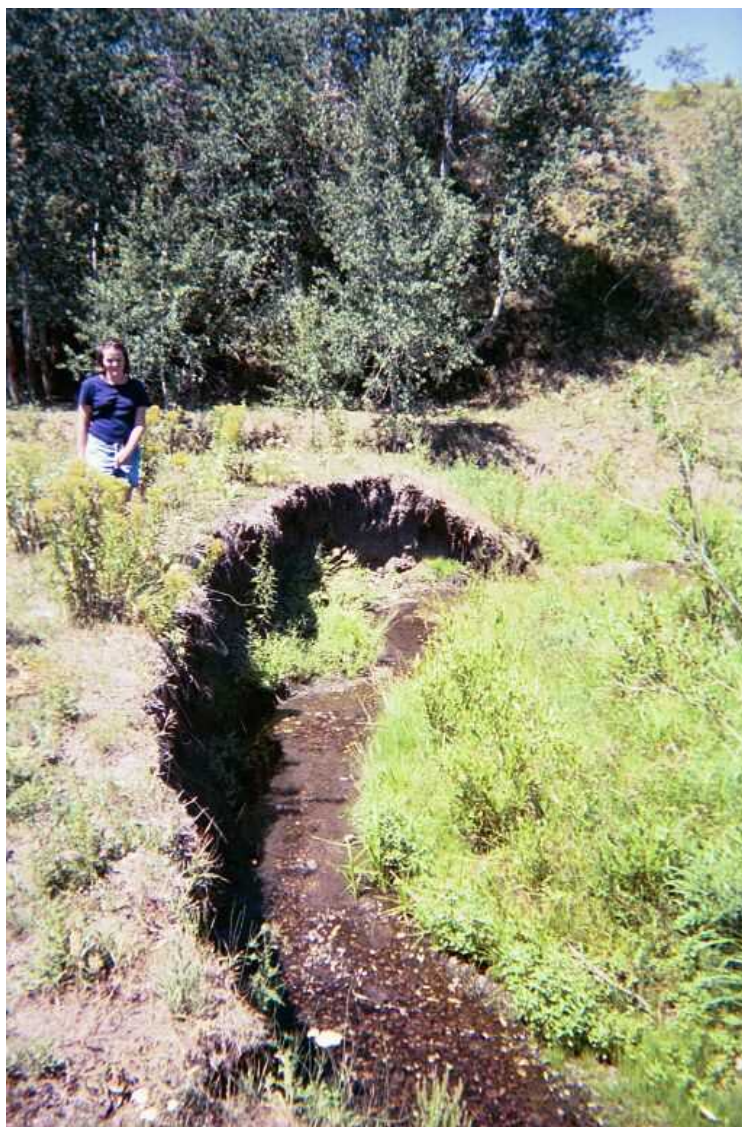
The channel was incised. Riparian vegetation extended at least one-half of the active channel width. Stream banks were unstable. About Less than 20% of the creek was shaded. No evidence of livestock access to the riparian area was noted. There were no fish migration barriers in this reach.

The reach was found to have slumps and clumps sloughing off. Stream banks were bare with no vegetative cover. Average bank height was about 5 feet. Channel bottom in silts with evidence of downcutting and recent deposition. This reach had riprap along eroding areas near the county road.

This NFRC9a photo was taken facing upstream.

- 1) Stream Habitat Improvement and Management (NRCS PS-395)
  - With Riparian Forest Buffer (NRCS PS-391A), Fencing (NRCS PS-382), Use Exclusion (NRCS PS-472), Tree/Shrub Establishment (NRCS PS-612), Channel Vegetation (NRCS PS-322), Spring Development (NRCS PS-574), Water Well (NRCS PS-642), Watering Facility (NRCS PS-614), Pipeline (NRCS PS-516)

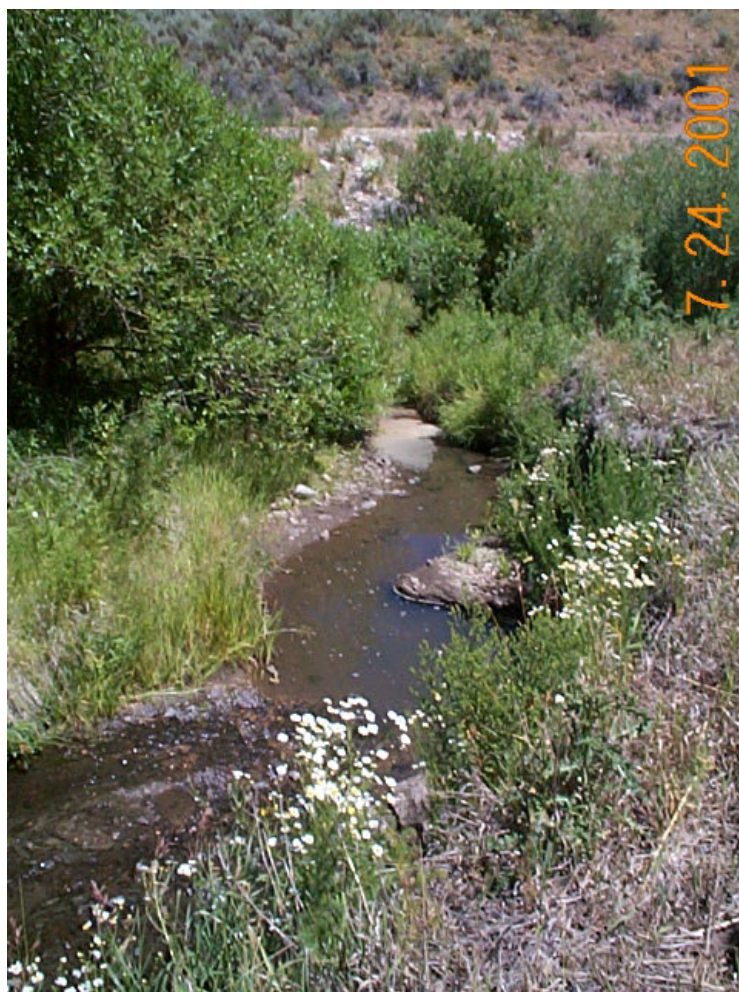
This NFRC9b photo was taken facing upstream.

- 1) Stream Habitat Improvement and Management (NRCS PS-395)
  - With Riparian Forest Buffer (NRCS PS-391A), Channel Vegetation (NRCS PS-322), Tree/Shrub Establishment (NRCS PS-612)

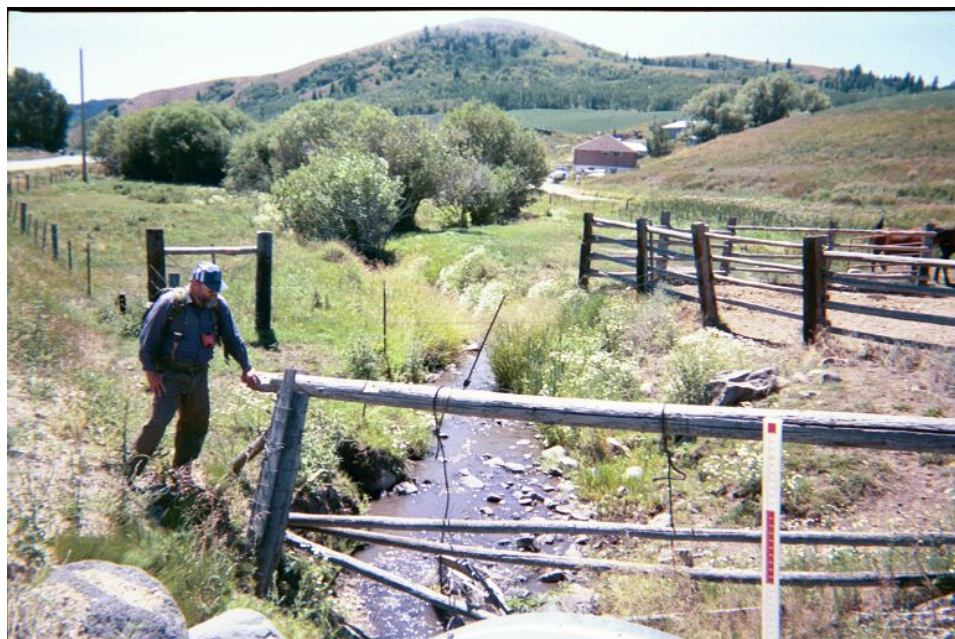
This photo was taken facing downstream at the start of NFRC10.

The channel is slightly incised. Riparian vegetation extended at least one active channel width. Stream banks were moderately unstable. About 20% to 50% of the creek was shaded. Livestock

were able to access the creek. Two animal feed operations were located within the reach. Road culverts were possible fish migration barriers in this reach. The reach was found to have erosion and cracking present on stream banks at the top of the reach. Stream banks were predominantly bare and unprotected and with mixed annual and perennial vegetation. Average bank height was about 4 feet. Channel substrates were silts with recent deposition.

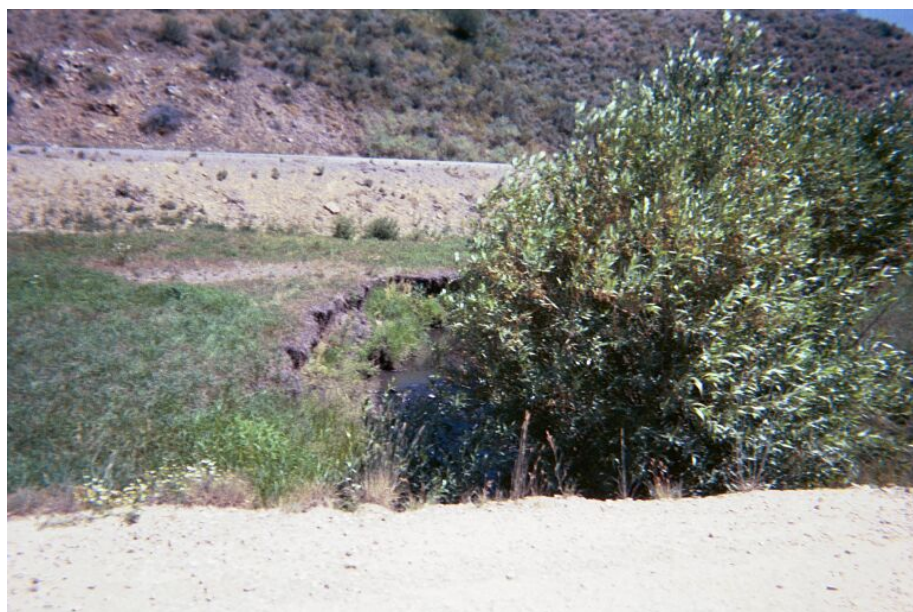
This photo was taken facing downstream at the beginning of NFRC11.

The channel is moderately incised. Riparian vegetation extended at least one active channel width. Stream banks were moderately unstable. About 20% to 50% of the creek was shaded. Occasional manure was found in the creek. A road culvert was possibly a fish migration barrier in this reach. The reach was found to have erosion and cracking present on stream banks. One blown out inactive beaver dam was present. Stream banks were predominantly bare and unprotected and with mixed annual and perennial vegetation. Average bank height was about 5 feet. Channel substrates were silts with recent deposition.

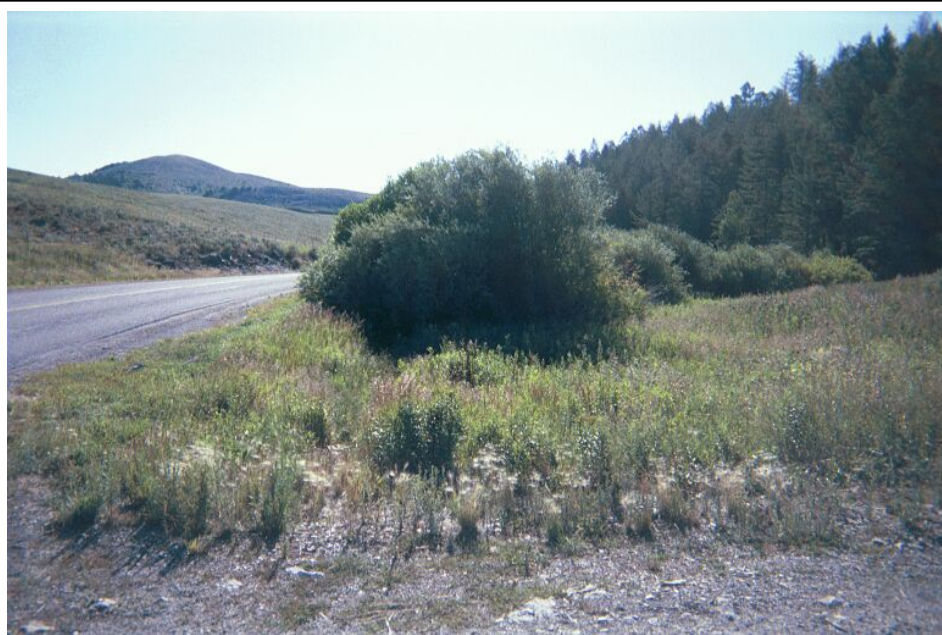
This photo of WFRC4 was taken looking downstream.

The channel was not incised. Riparian zone vegetation extended at least two active channel width. Stream banks were low and stable. Willows were abundant. More than 75% of the creek was shaded.

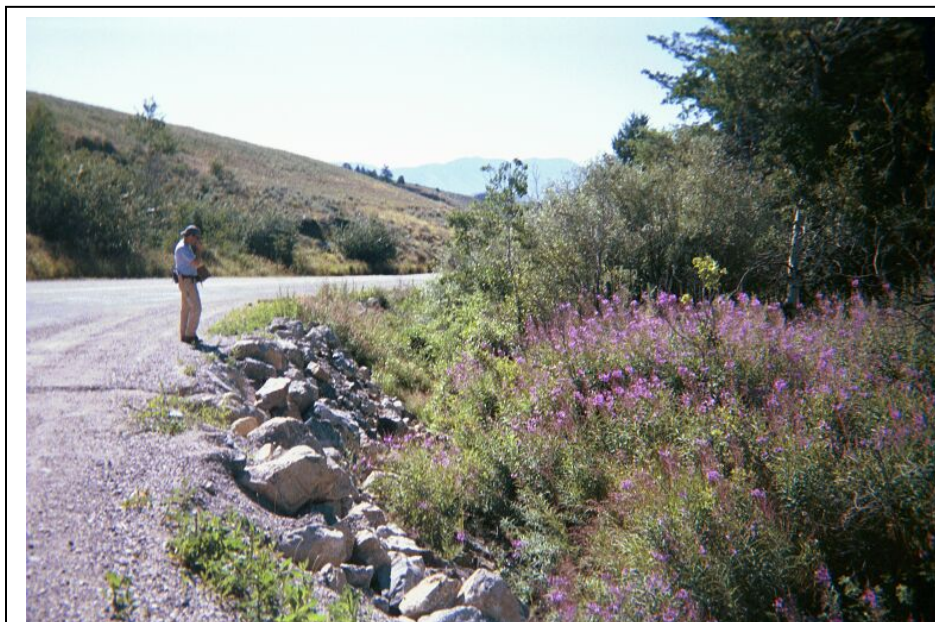
This photo of WFRC5 was taken looking downstream.

The channel is deeply incised. Riparian zone vegetation extended less than a third of the active channel width. Stream banks were high and unstable. Less than 20% of

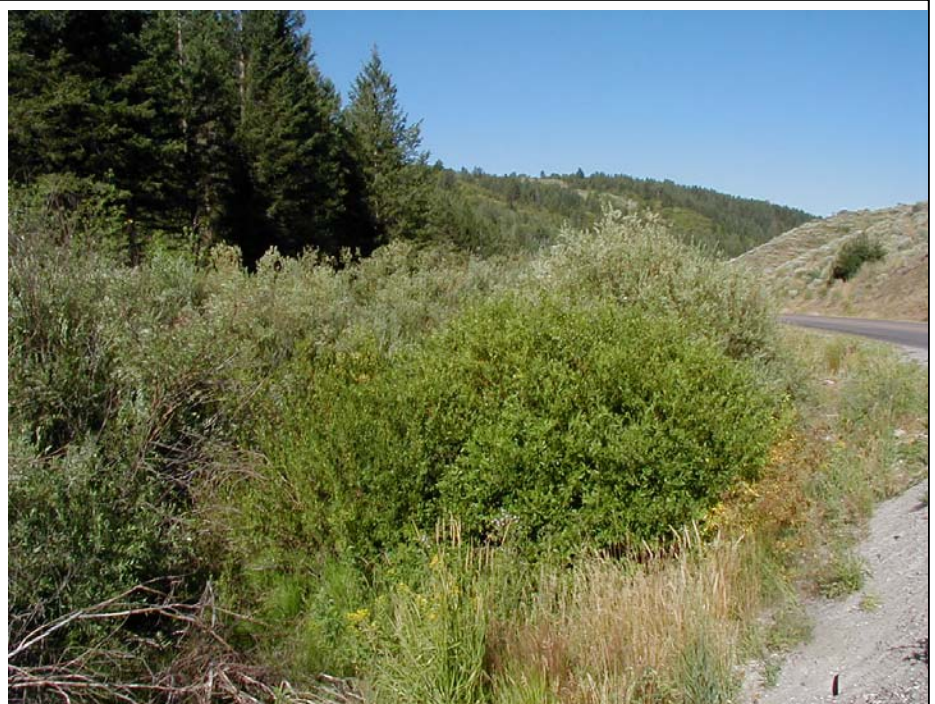
This photo of WFRC9 was taken looking downstream.

The channel is not incised. Riparian zone vegetation extended at least two active channel widths. Stream banks were low and stable. More than 75% of the creek was shaded. There was no evidence of livestock access to the riparian area. The reach

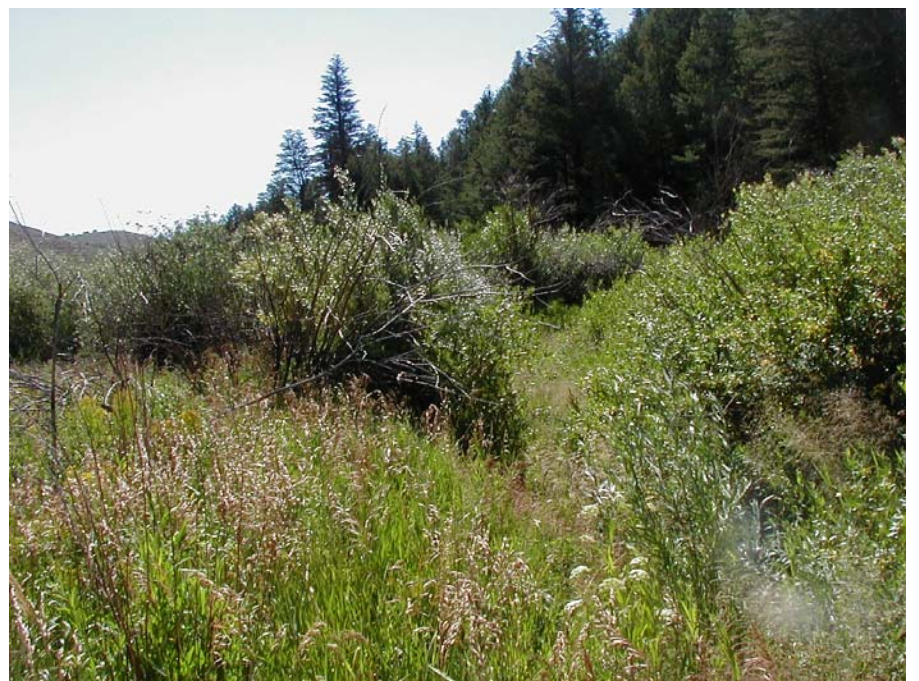
This photo of WFRC11 was taken looking downstream.

The channel is not incised. Riparian zone vegetation extended at least two active channel widths. Stream banks were low and stable. More than 75% of the creek was shaded. There was no evidence of livestock access to the riparian area. The reach was vertically stable. The reach does not appear to be eroding. There were very little unprotected banks, which were covered by perennial vegetation. Average bank height was about 2 feet. Channel substrates consisted of silt, sand and gravel with no evidence of deposition.

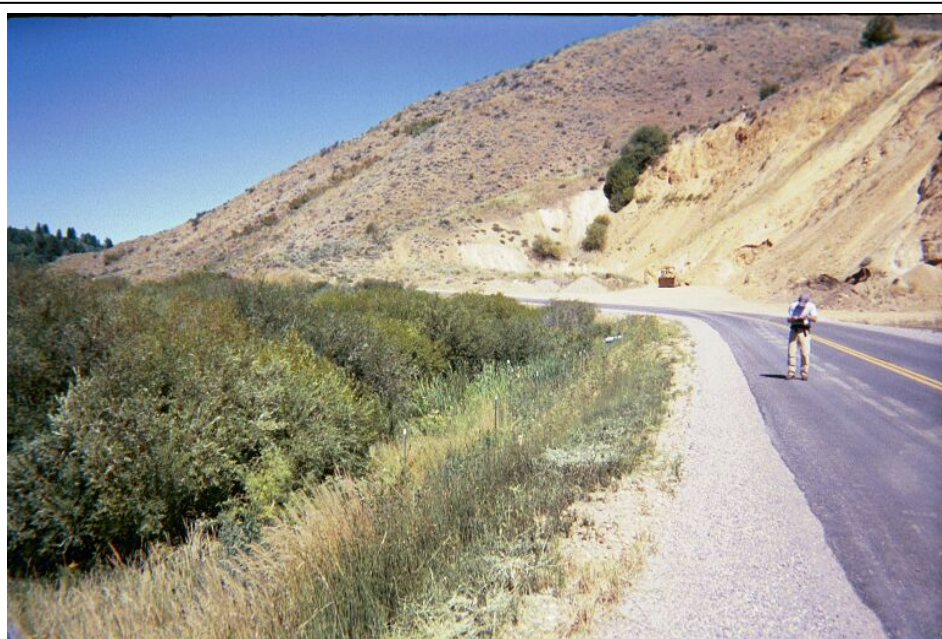
This photo of WFRC13 was taken looking downstream.

The channel is not incised. Riparian zone vegetation extended at least two active channel widths. Stream banks were low and stable. More than 75% of the creek was shaded. There was no

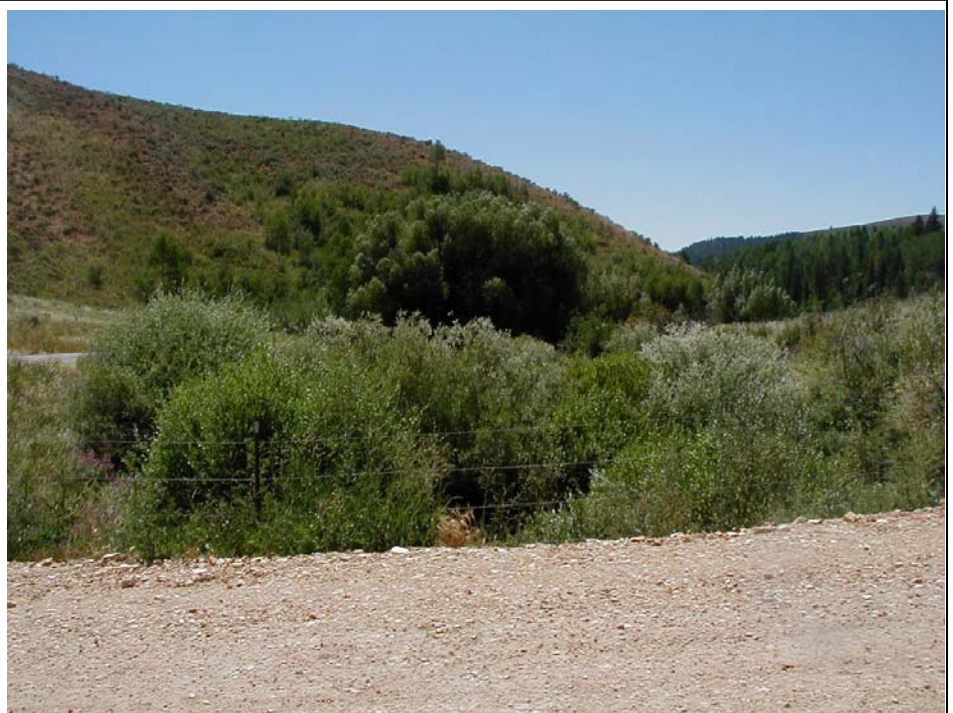
The channel is incised. Riparian zone vegetation extended at least one active channel width. Stream banks were low and moderately stable. About 20% to 50% of the creek was shaded. There was no evidence of livestock access to the riparian area.

This photo of WFRC14 was taken looking downstream from the start.

The reach was vertically stable. The reach does not appear to be eroding. There were very little unprotected banks, which were covered by perennial vegetation. Average bank height was about 3 feet. Channel substrates consisted of silt, sand and gravel with no evidence of deposition.

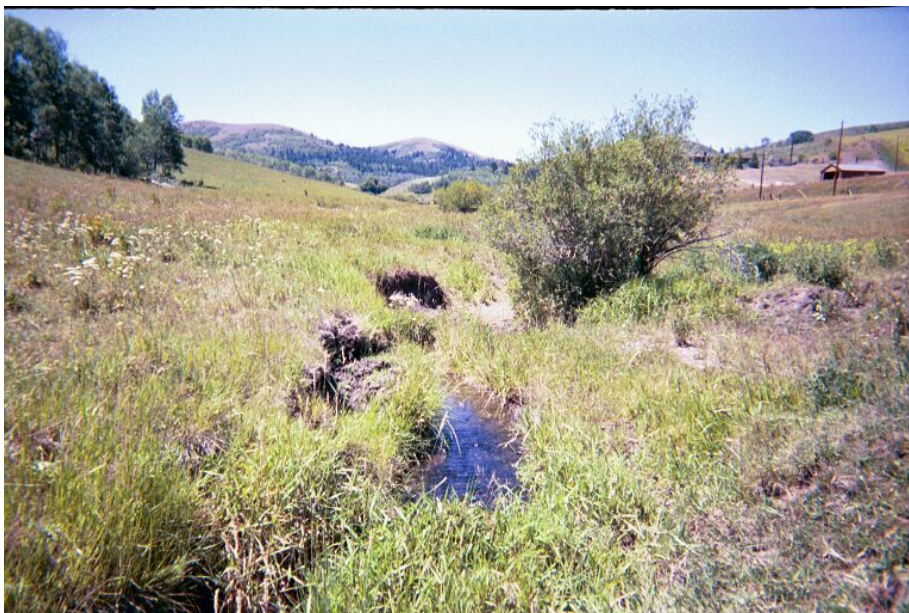
This photo of WFRC18 was taken looking upstream from the end.

The channel is incised. Riparian zone vegetation extends at least one third of the active channel width. Stream banks were high and unstable. Less than 20% of the creek was shaded. There was extensive amount of manure on the banks and in the creek. A small animal feed operations was present within the reach. The reach had several headcuts and was vertically unstable with possible fish migration barriers. The reach is severely eroding. There were very little protected banks with evidence of livestock trampling. About 40% of the banks were bare with the remainder covered by a mixture of highly utilized annual and perennial vegetation. Average bank height was about 3 feet. Channel substrates consisted of silt, sand and gravel with evidence of recent deposition.

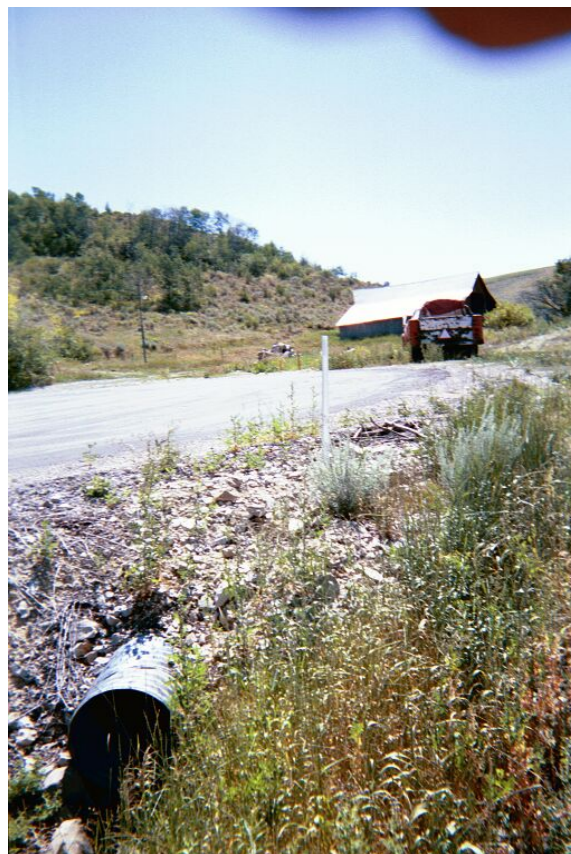
The channel was slightly incised. Riparian zone vegetation extended at least one active channel width. Stream banks were somewhat high and recovering but stable. 20 to 50% of the creek was shaded. There was evidence of livestock access to the riparian area. A small animal feed operation was present within the reach. The reach was stable with the culvert posing a fish migration barrier. The reach does appear to be eroding with some unprotected bank. Stream banks were covered with perennial vegetation. Average bank height was about 4 feet high. Channel substrates were silts. The upper 80 feet of the reach has been covered and put into a 24" culvert pipe.

This photo of HC2 was taken looking upstream.

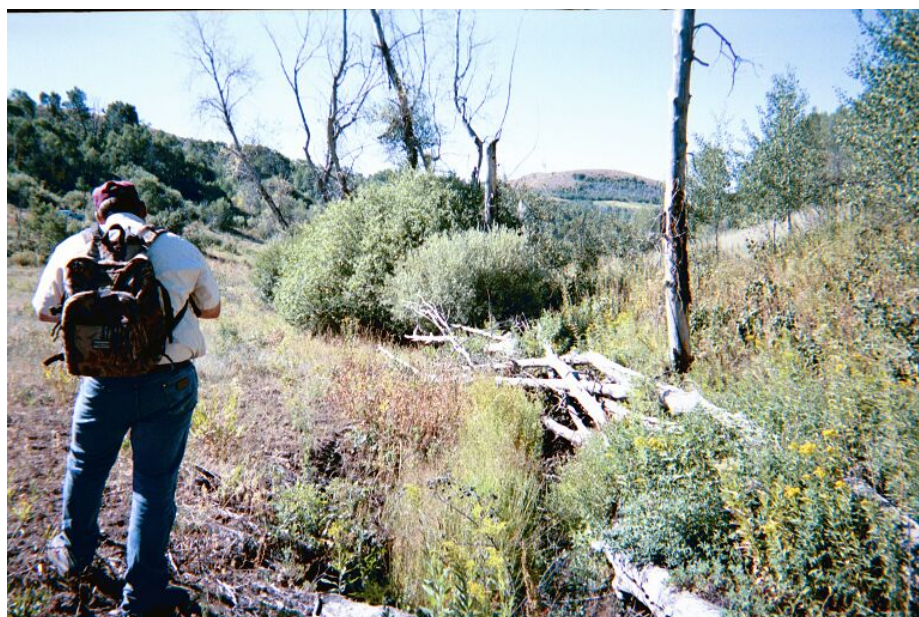
This photo of MNC4 was taken looking downstream at the start of the reach.

The channel is not incised. Riparian zone vegetation extended at least one active channel width. Stream banks were low and stable. More than 50% of the creek was shaded. Several species of willows were observed and cottonwoods. There was evidence of livestock access to the riparian area. The animal feed operation located in reach HC2 also extends into the lower end of this reach.

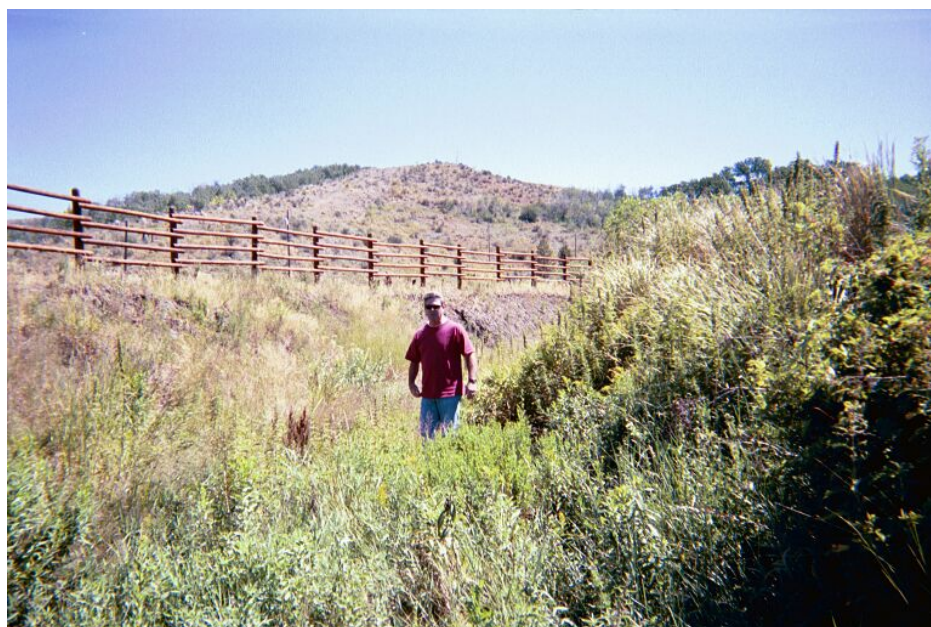
This photo of MNC5a was taken looking upstream.

The channel is incised. Riparian zone vegetation extended at least one active channel width. Stream banks were somewhat high and unstable. 20% to 50% of the

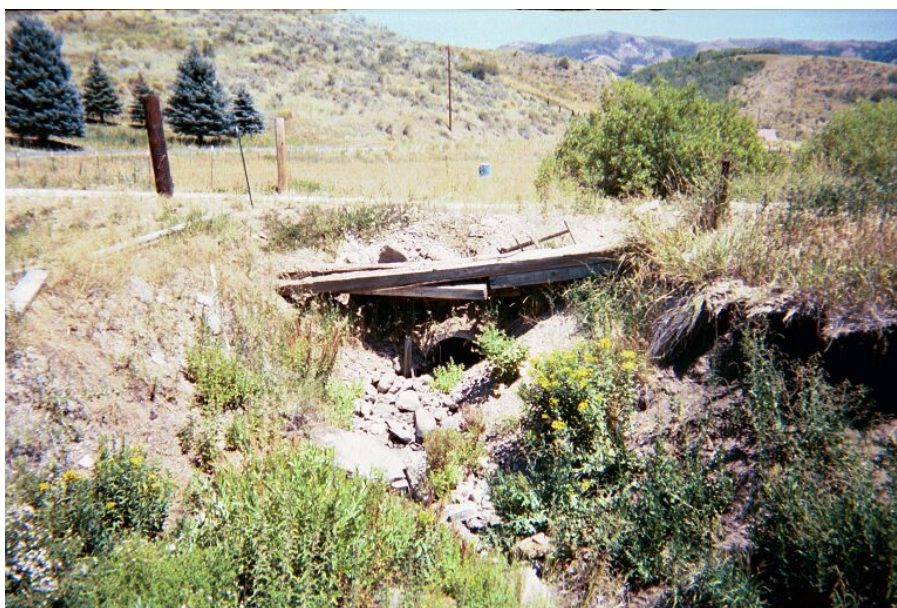
This photo of MNC5b was taken looking upstream in the middle of the reach.

The channel is deeply incised. Riparian zone vegetation extended at least one active channel width. Stream banks were high and unstable. 20% to 50% of the creek was shaded. There was occasional manure in the creek. Two small animal feed operations are present within the reach. The reach was vertically unstable with some minor head cuts. A culvert is possibly a fish migration barrier within the reach. The reach does appear to be eroding. About 40% to 70% bare stream banks covered by annual and perennial vegetation. Average bank height was about 7 feet. Channel substrates consisted of silt and gravel with evidence of recent deposition.
